Major Maintenance and Repair Action

Hull 269 – Jade

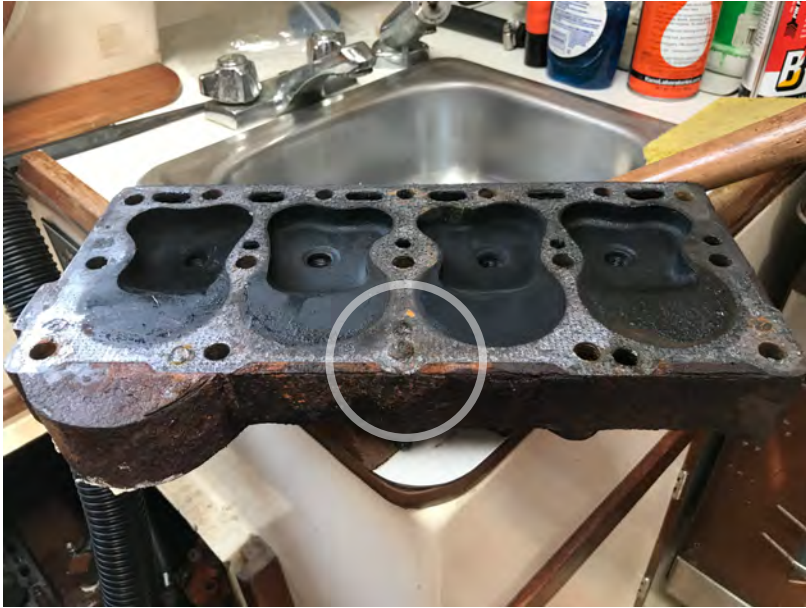
Old Cylinder Head Removed - Stud #8 (circled) broken off in head

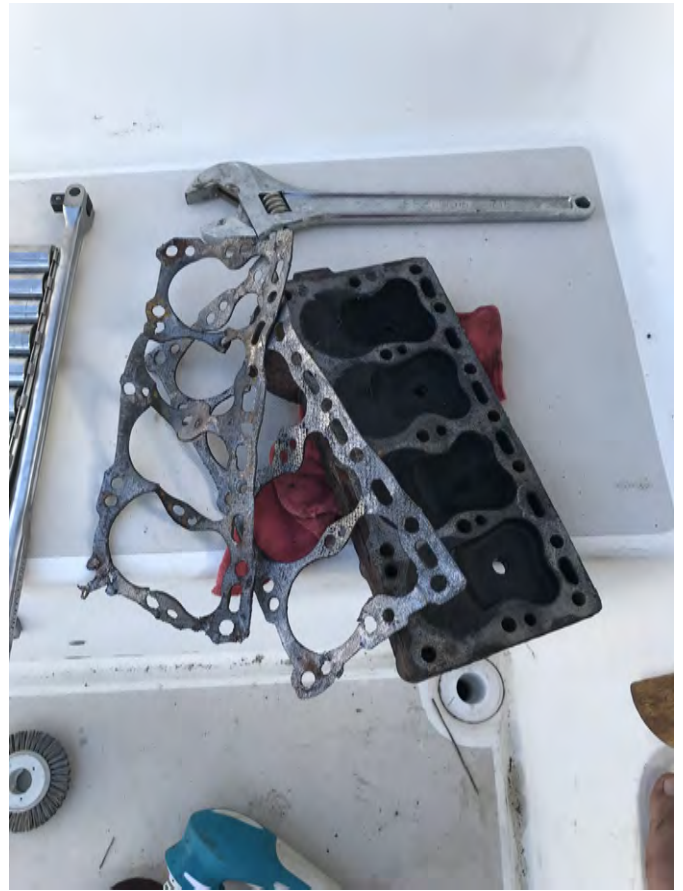
Old Cylinder Head and Head Gaskets

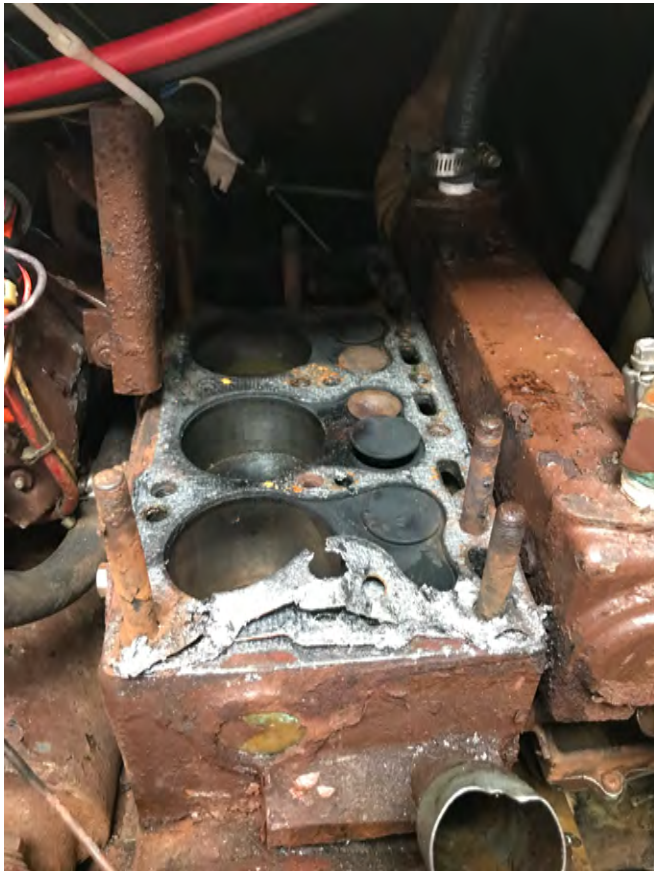
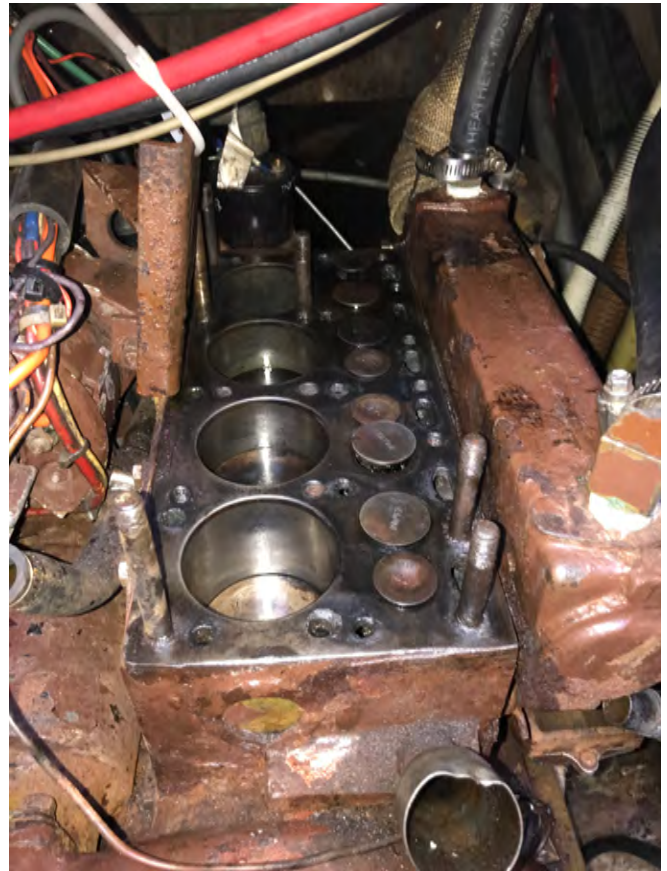
Cylinder Block after Head removal and in process of being cleaned - Six studs remain in block. Piston and valve heads and cylinders appear in good condition

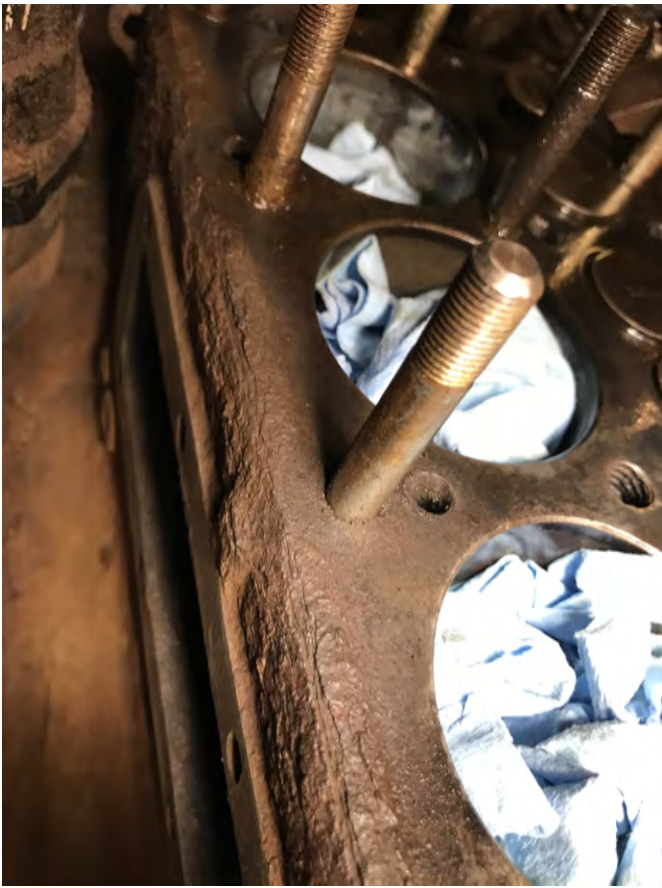
Of concern was starboard side with corrosion - preservation required

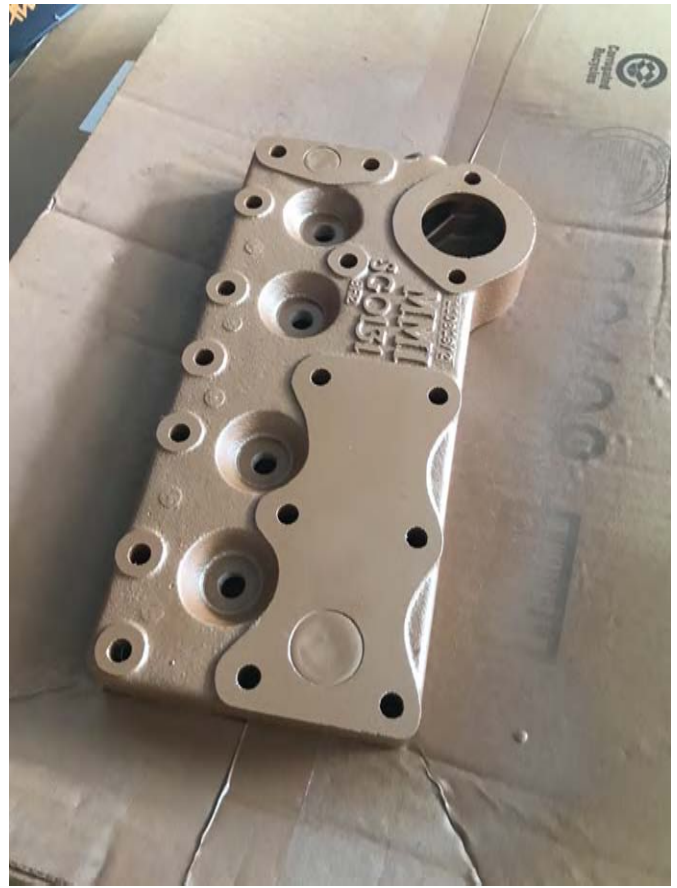
New Cylinder Head Painted with High Temperature "Antique Copper" Paint

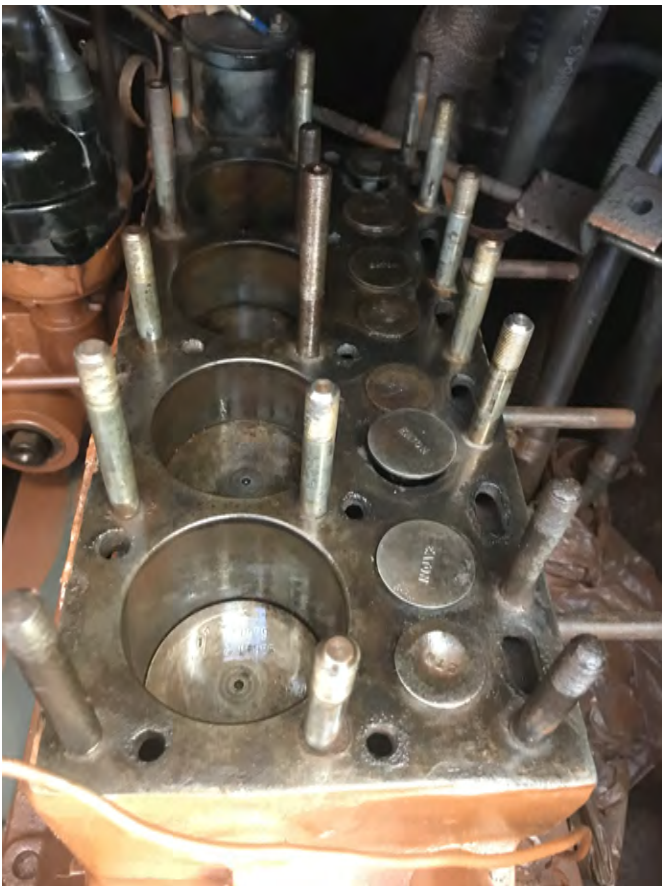
Eleven new studs installed - nylon zip tie used to ensure clear cooling passages

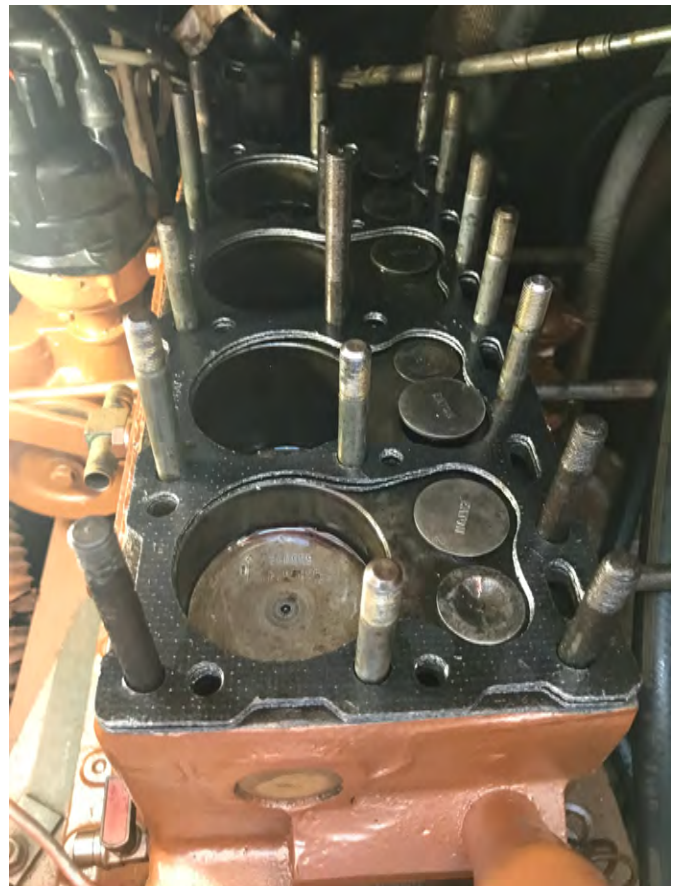
After final cleaning, two head gaskets placed before cylinder head installation

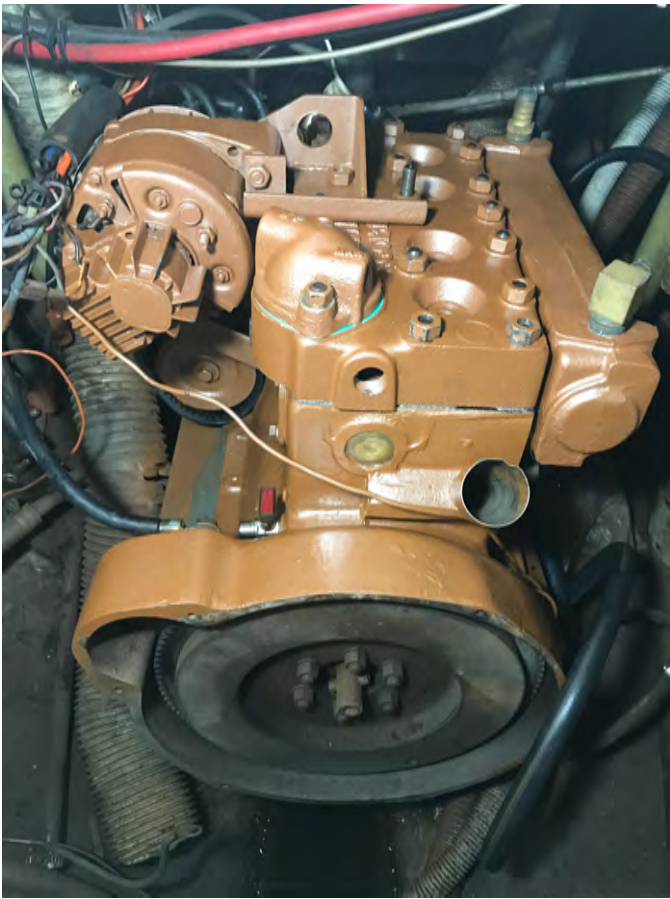
Engine block preservation completed, head installed and tightened as per manual (25, 30, and 35 ft-lbs of torque)

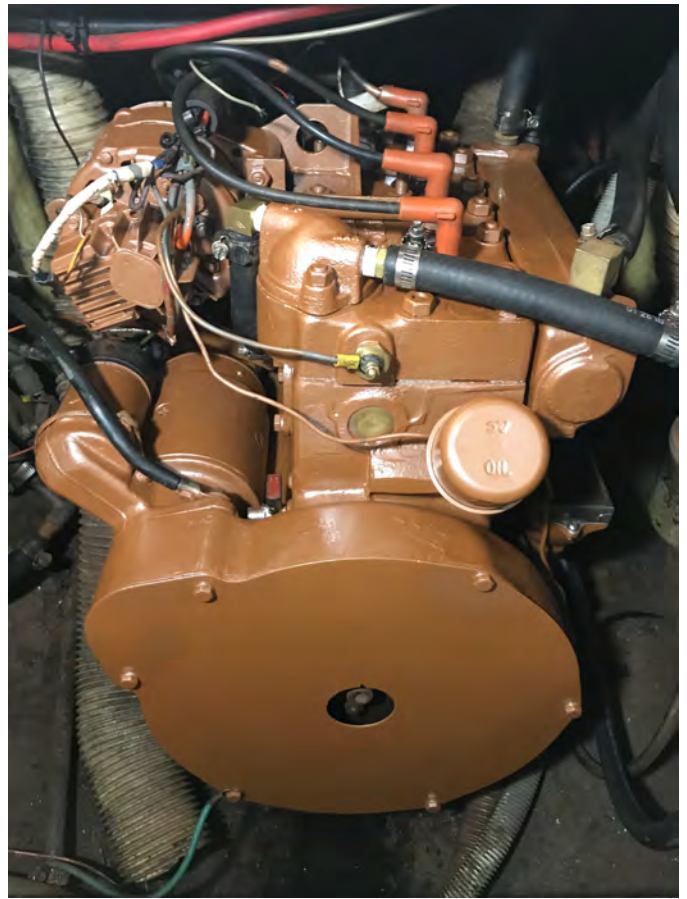
Final reassembly - note the nuts were also painted to prevent rust
