## Major Maintenance and Repair Action

Hull 269 – Jade

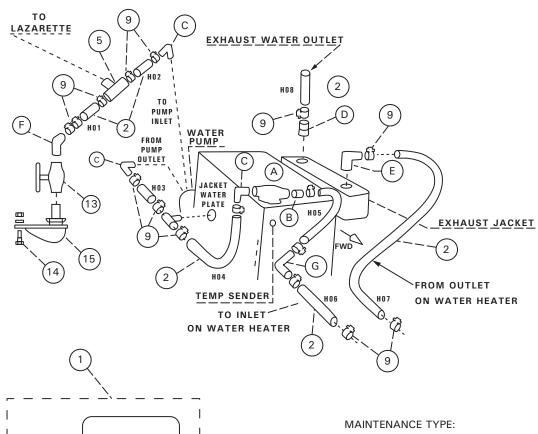
iterials, Manuals, and Diagrams Used		Used		
5/8" Cooling H	lose (Automotive)	Name Gasket, Exhaust Flange	Part Number GASK 07 146		
	ss, 3/8" MNPT X 5/8", Straight x 2	Gasket, Manifold	GASK 08 147		
	ss, 3/8" MNPT X 5/8", 90° x 2	Gasket, Carburetor Flange	GASK 10 149		
	les, Elbows, and Valves for Drains	Gasket, Water Jacket Plate	GASK 04 143		
	hic 4 Service and Overhaul Manual	Gasket, Water Pump	GASK 17 156		
	Engine Water Circulating System Diagram (As Built)

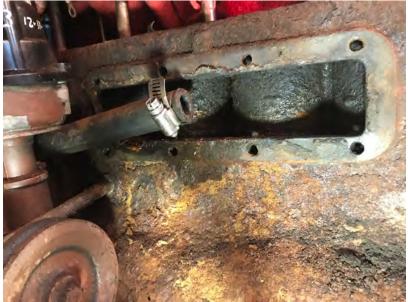
Jacketwater Side Plate Removed

View of Cooling Water side of the Cylinder Block

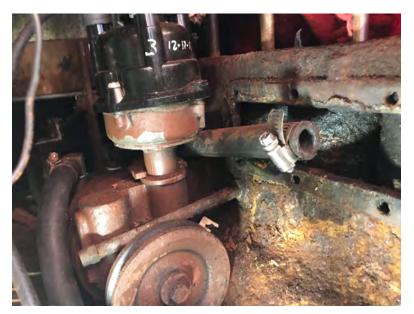
At center, note the corroded 6 inch drain pipe with cap - it easily broke off at the threads when a small force was applied and replaced later

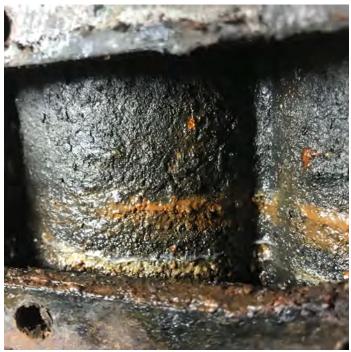
Inspection close up of water side of Cylinder Liner - appears to be in good condition

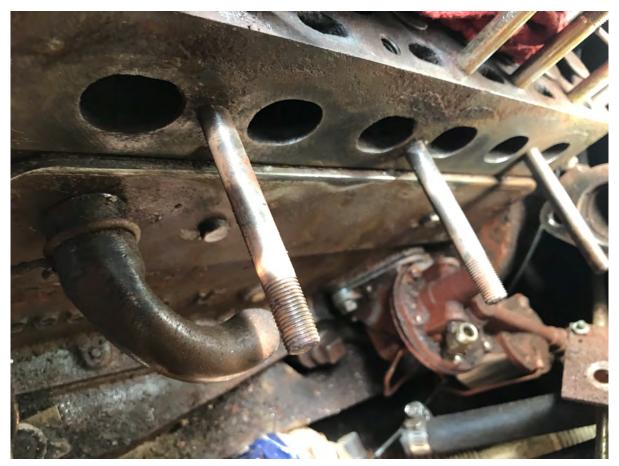
Manifold and Gasket Removed

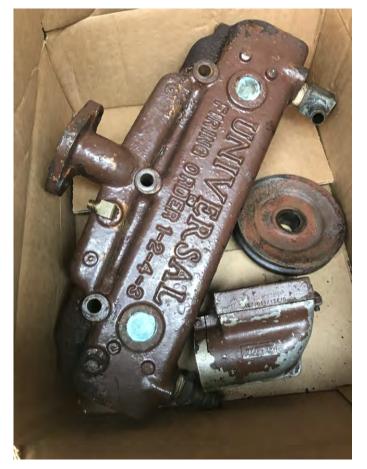
Manifold (and spark arrestor and pulley) before sandblasting

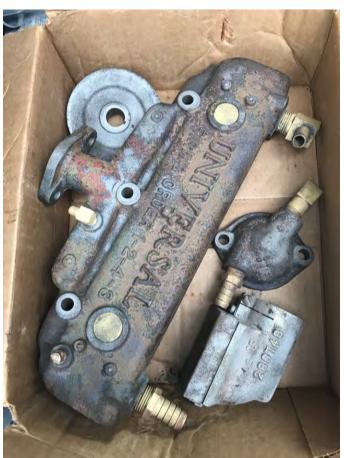
Manifold after sandblasting - internal passages were clear and cleaned

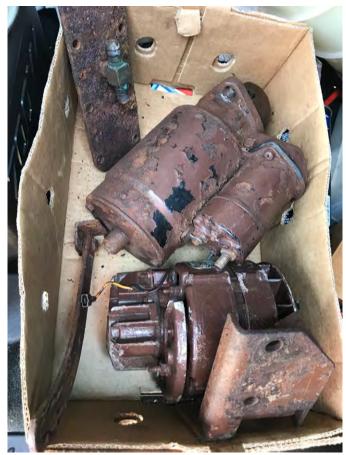
Jacket Water Plate (upper left corner) before sandblasting and cleaning

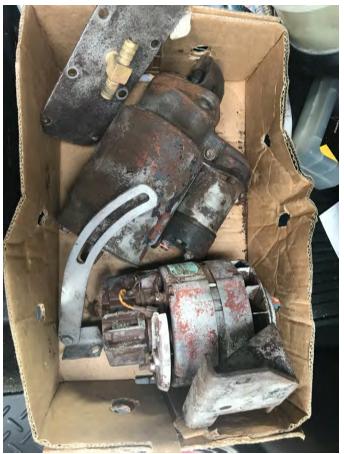
Jacket Water Plate (upper left corner) after sandblasting

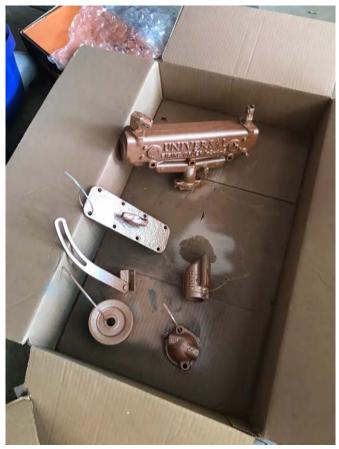
Manifold (painted only with high temperature spray paint) and Jacket Water Plate (primed and high temp paint applied)

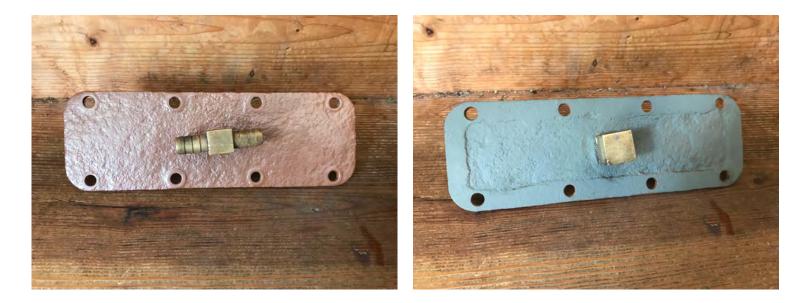
Jacket Water Plate primed and painted with high temperature spray paint - water side of plate was primed only

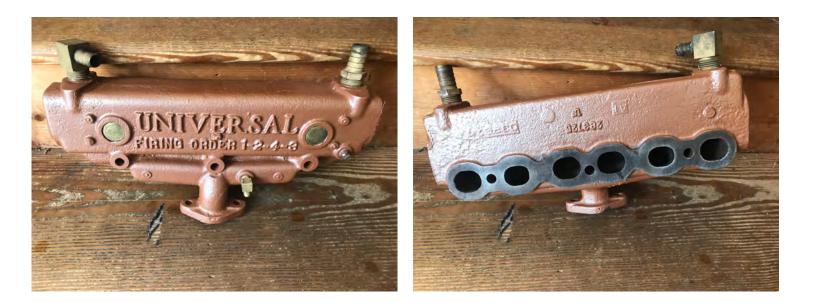
Manifold painted with high temperature spray paint - 1/2" MNPT to 5/8" hose barb fittings were not removed

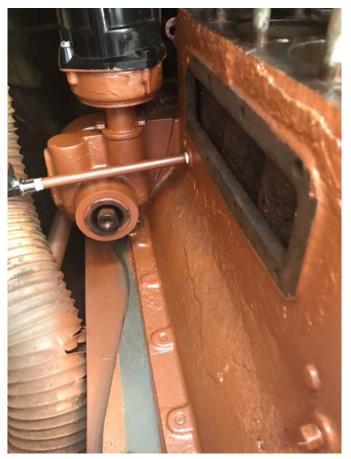
Jacket Water Plate access cleaned and engine painted, new 6" drain pipe and valve installed

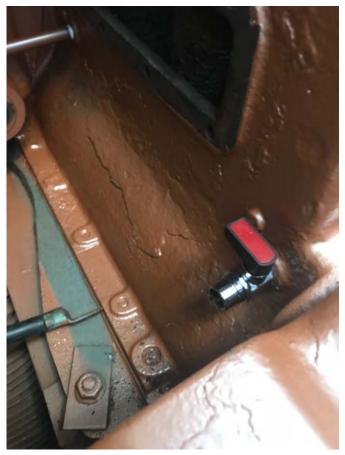
Forward 1/8" drain plug replaced with stainless steel 1/8" drain valve

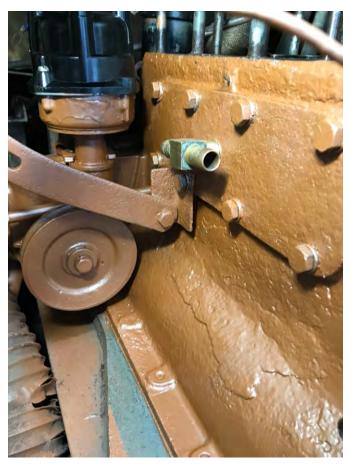
Jacket Water Plate reinstalled - note location of alternator bracket

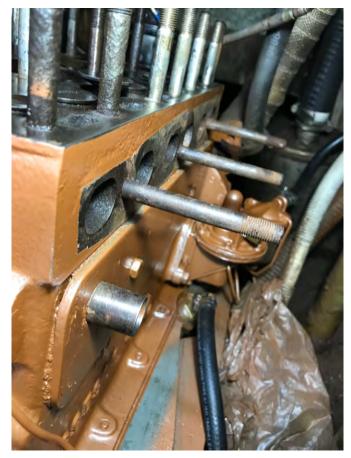
Manifold face cleaned and engine painted with high temperature spray paint

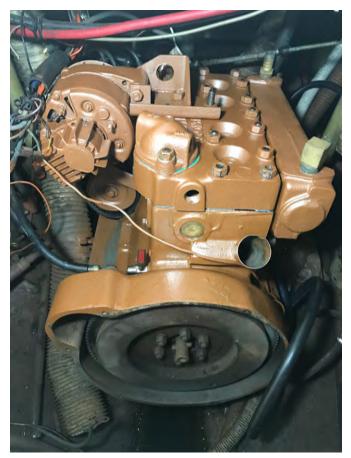
Manifold reinstalled and tightened to 25 ft-lbs of torque

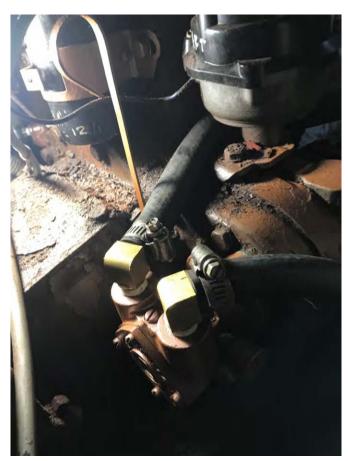
Overhauled water pump installed and new 5/8" hoses reattached

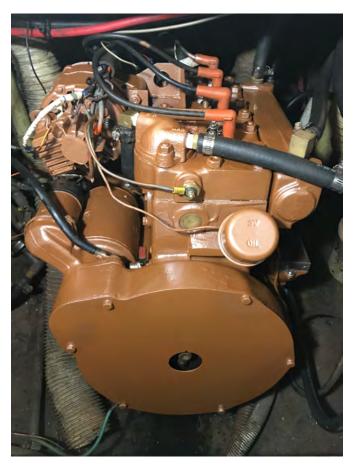
Cooling system reassembled with new 5/8" cooling hoses
