Major Maintenance and Repair Action

Hull 269 – Jade

Maintenance or Repair Action: Repaint Engine		Number: 006	
Reason for Action	Engine block and components rusting and corroding excessively	System	Engine
		Start	7/5/2018
		Complete	11/11/2018
		Cost	\$100.00
DESCRIPTION OF ACTION			
<p>The engine required descaling and painting due to excessive corrosion. Engine and parts coated with primer (at least two coats), except parts subjected to temperatures over 200 degrees. At least three coats of high temperature paint were applied to all components. All items were steel except where noted. The following components were removed (in conjunction with Repair Action #005, <i>Overhaul Cooling Water System</i>, and #004, <i>Replace Cylinder Head</i>), sandblasted, wire brushed, primed (except where noted), and painted with spray paint listed below:</p> <ul style="list-style-type: none"> • Cylinder Head (new, not primed) • Exhaust Jacket/Manifold (not primed) • Thermostat Housing (Bronze) • Jacket Water Side Plate • Alternator Support Bracket • Alternator Drive Pulley • Port and Starboard side of engine • Alternator (After painting, cleaned windings with electrical solvent) • Starter Motor

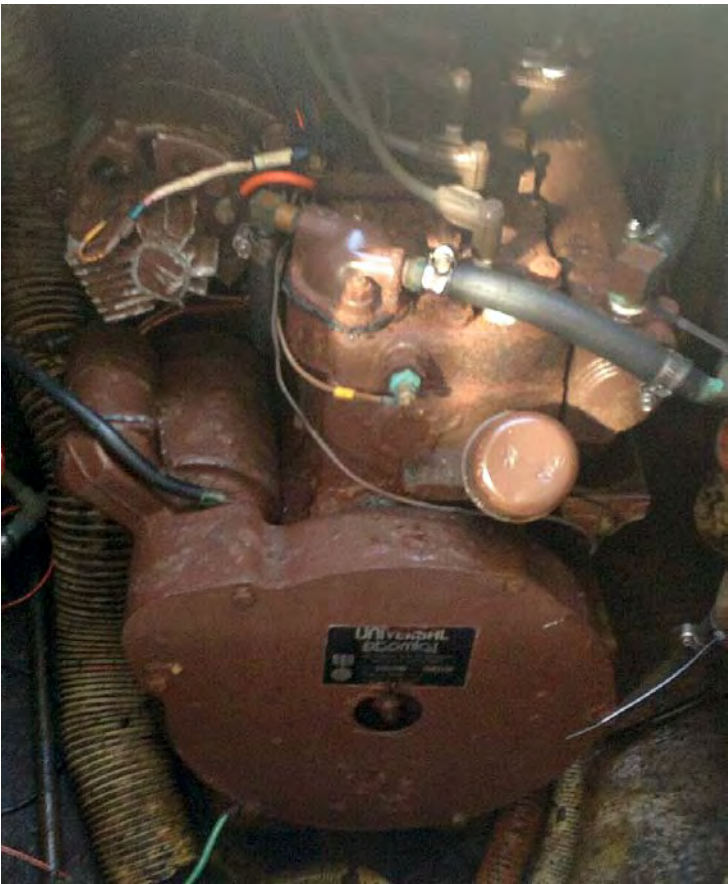
Engine as found, November 2017

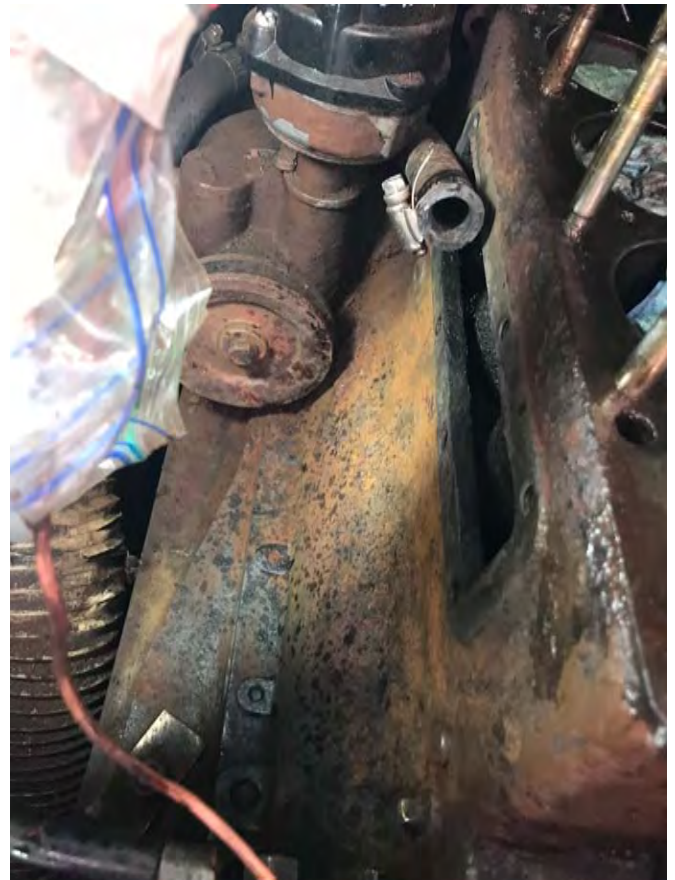
Starboard side of engine with Jacket Water Plate off, descaling in progress

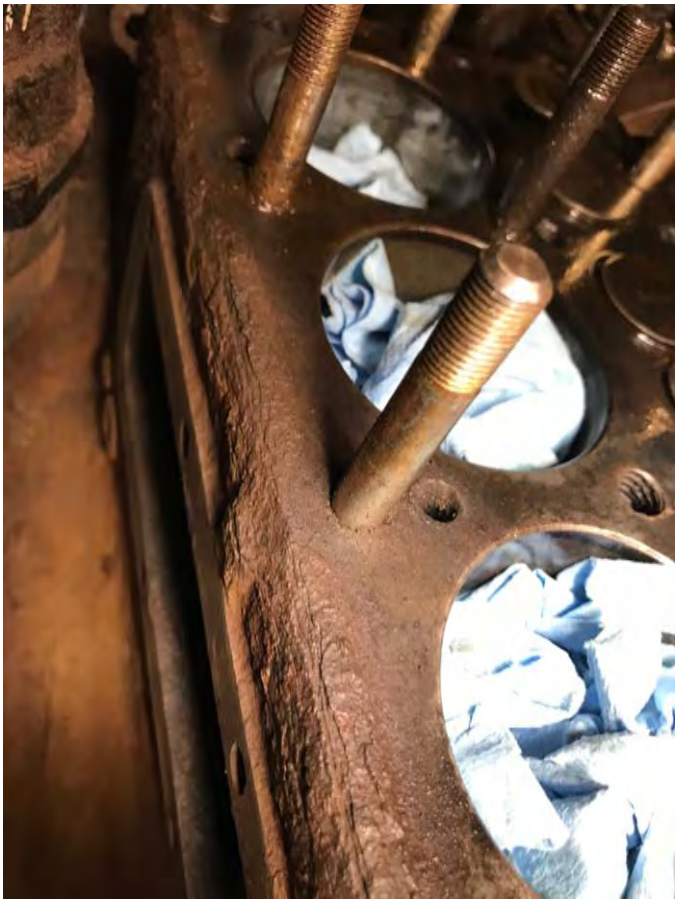
Close up of excessive corrosion on starboard side of engine block

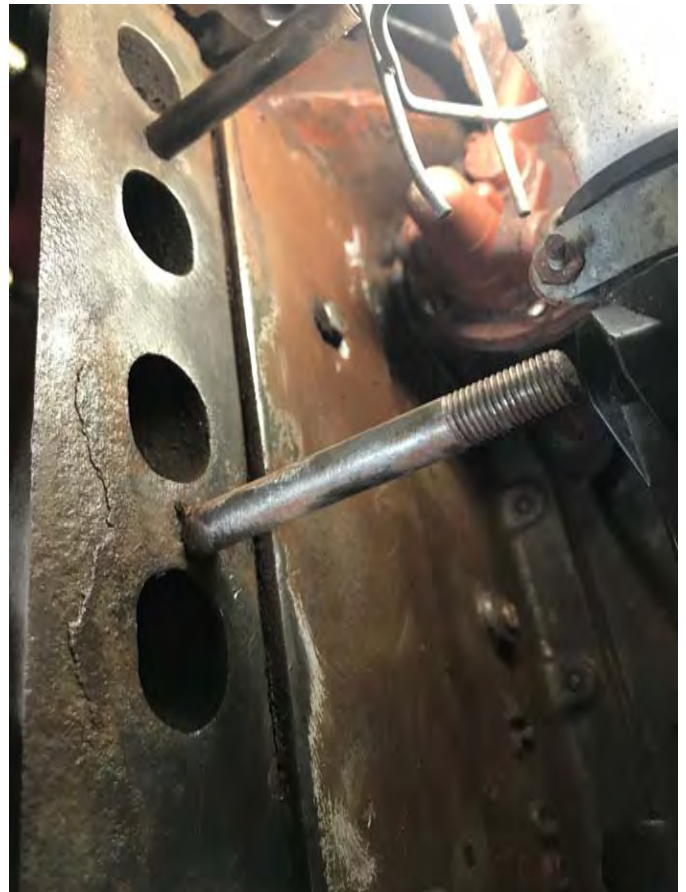
Port side of engine with Manifold removed, descaling in progress

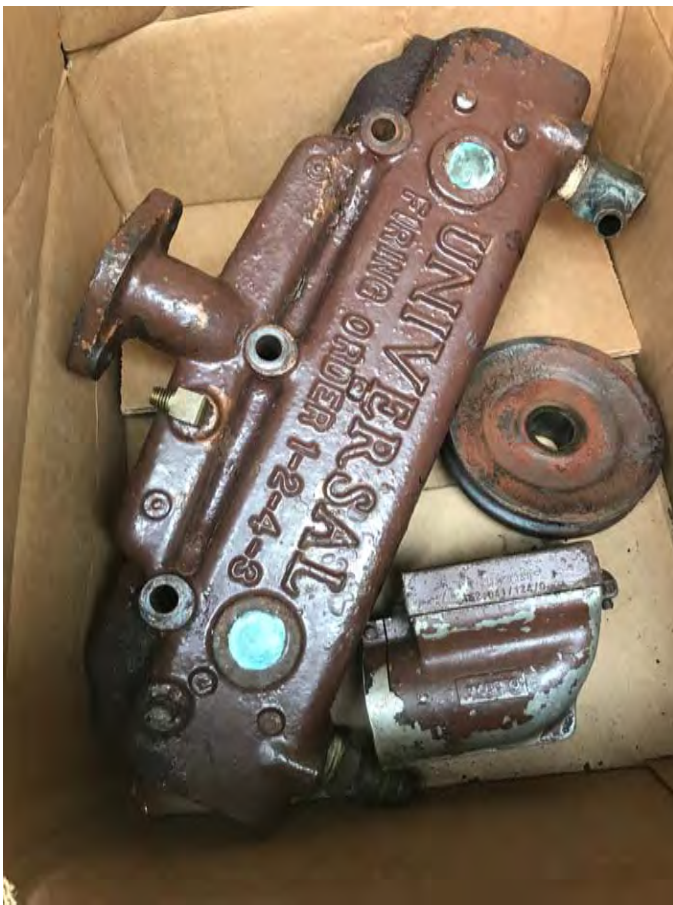
Manifold, Alternator Pulley, and Spark Arrester before sandblasting and cleaning

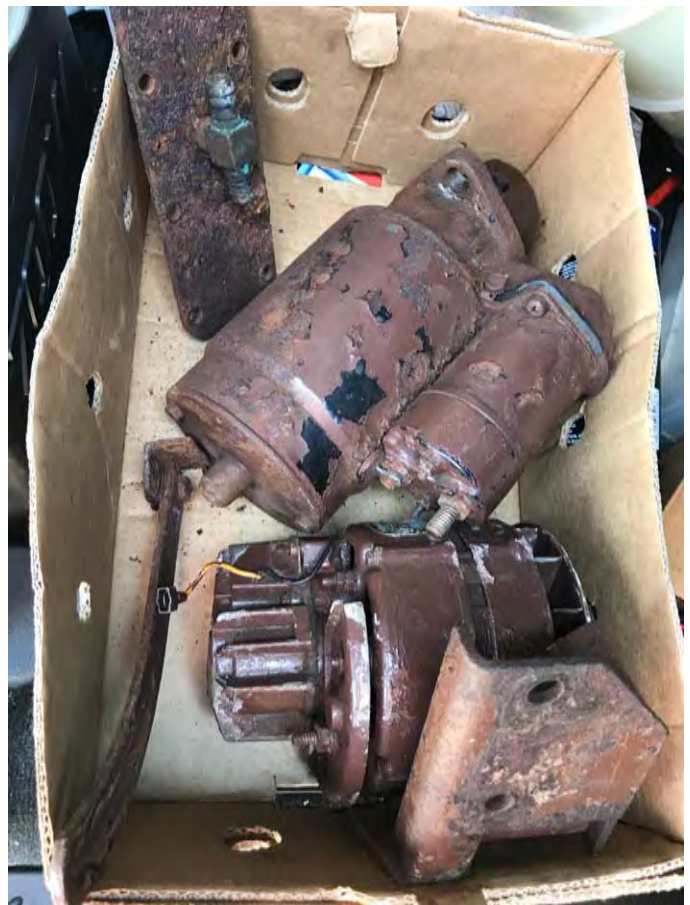
Jacket Water Plate, Starter Motor, Alternator and Alternator Support Bracket before

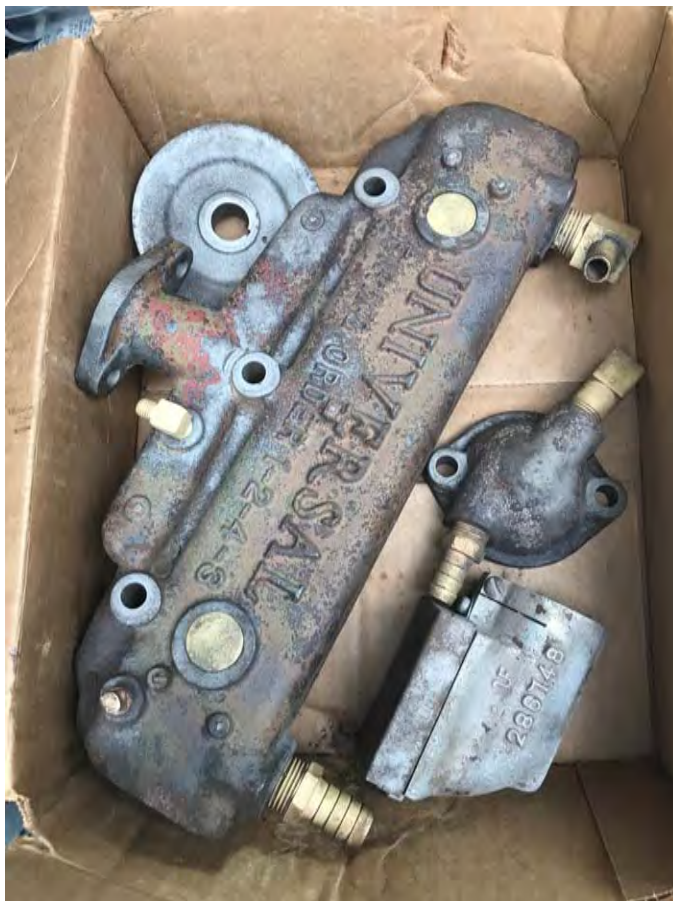
Components after sandblasting

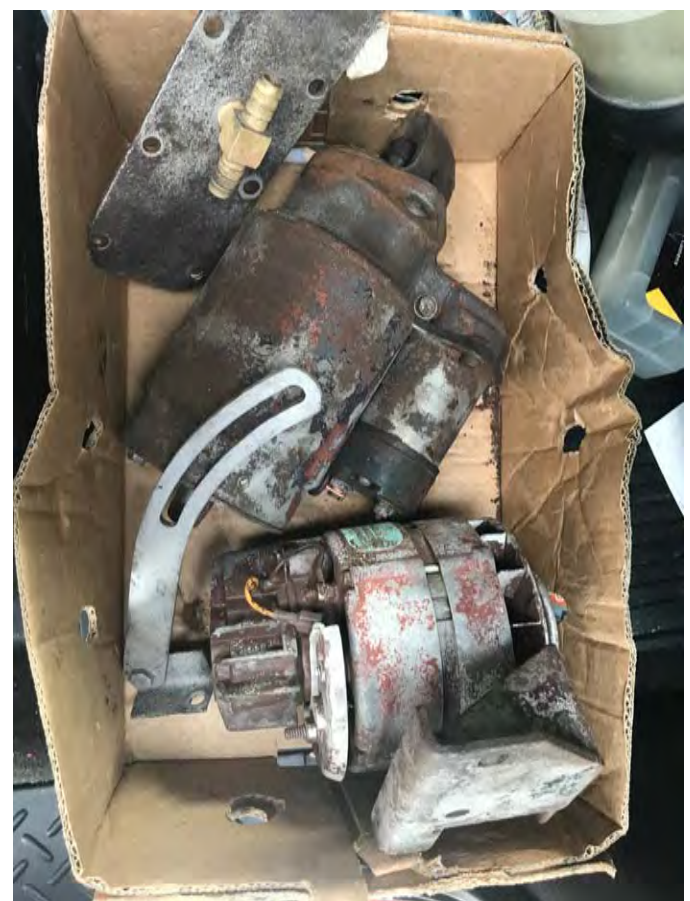
Components after sandblasting

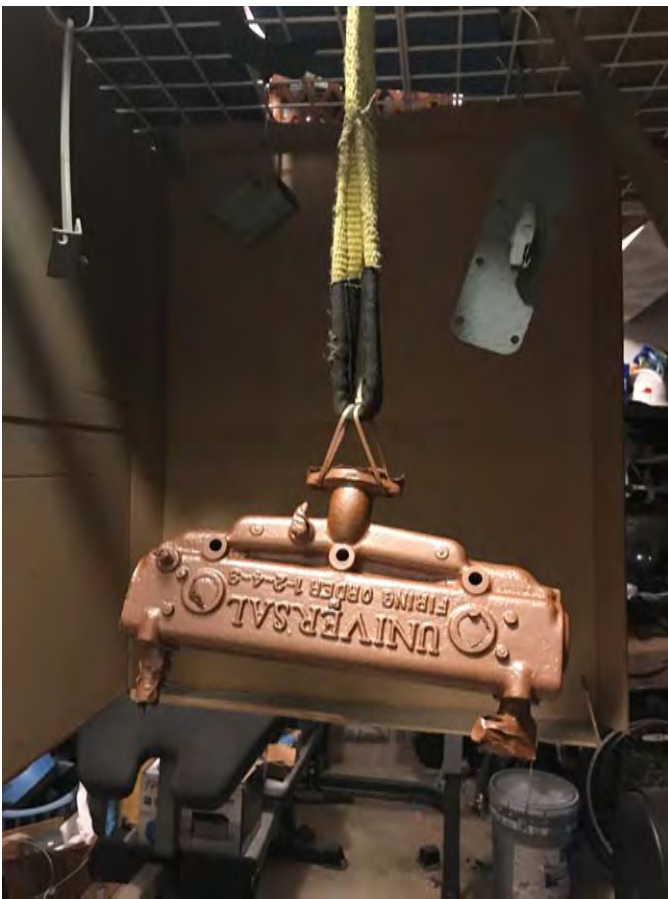
Manifold coated with high temperature paint, other pieces painted with self-etching primer

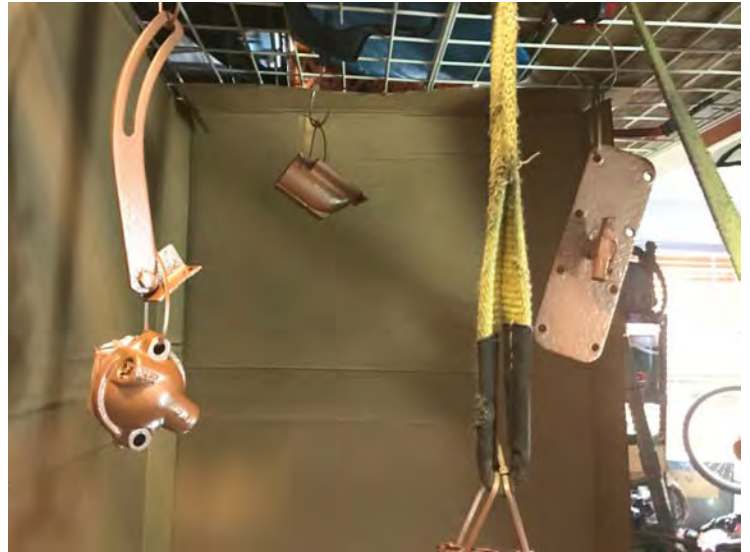
Coating alternator bracket, thermostat housing, jacket water plate, and flame arrester

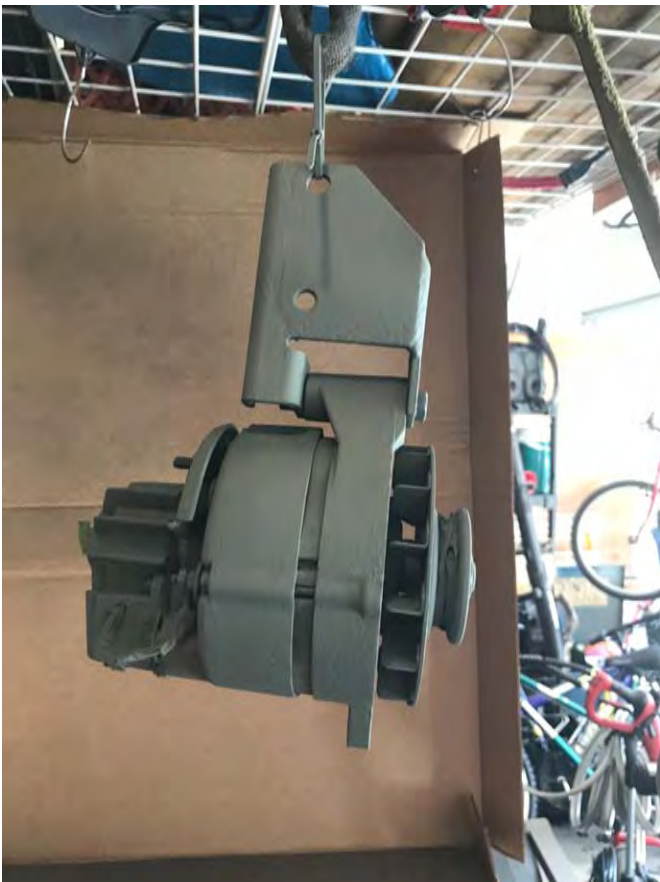
Spray painting alternator with self-etching primer (passages to windings closed with tape)

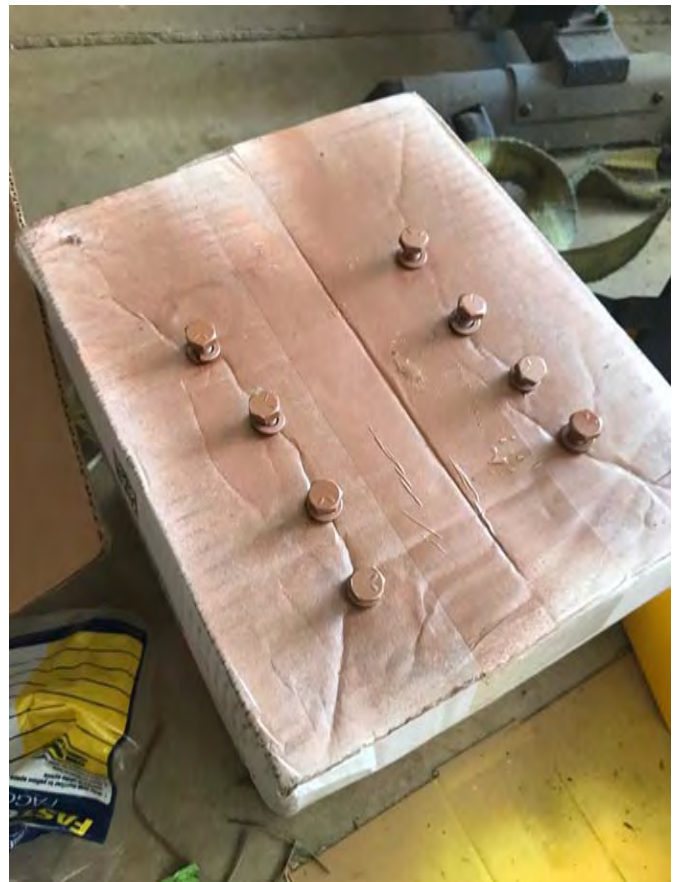
Painting bolts for Jacket Water Plate

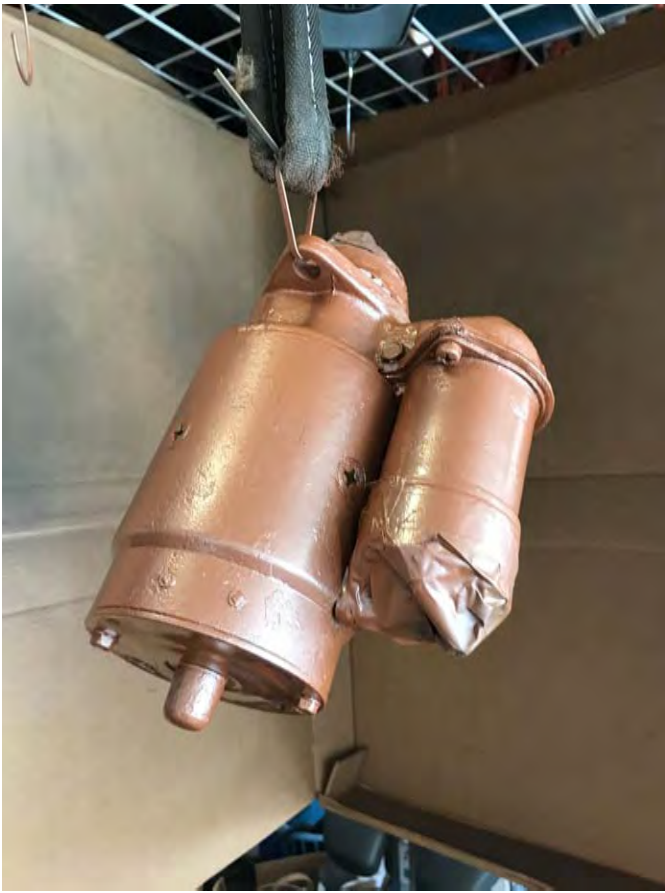
High temperature spray paint on Starter Motor/Solenoid

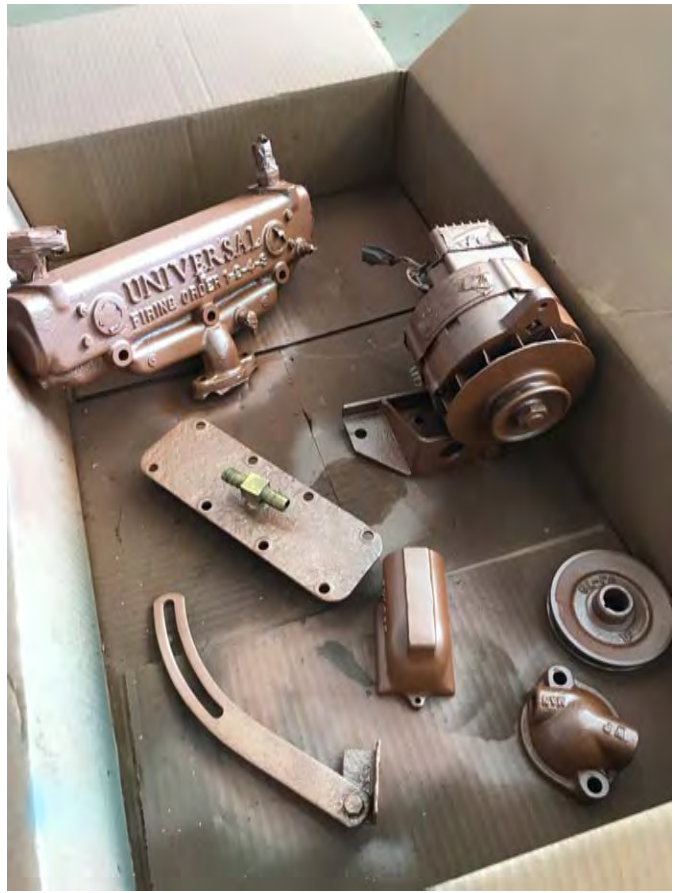
Setting components to dry for at least 24 hours

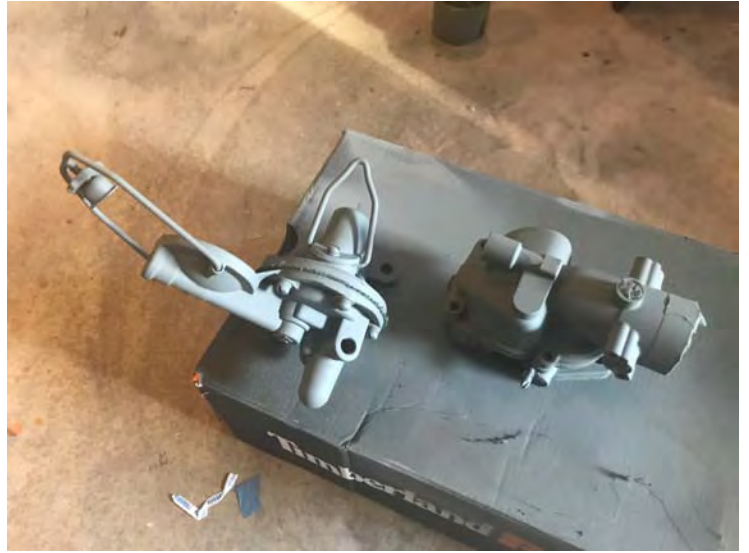
Fuel Pump Body with priming coat

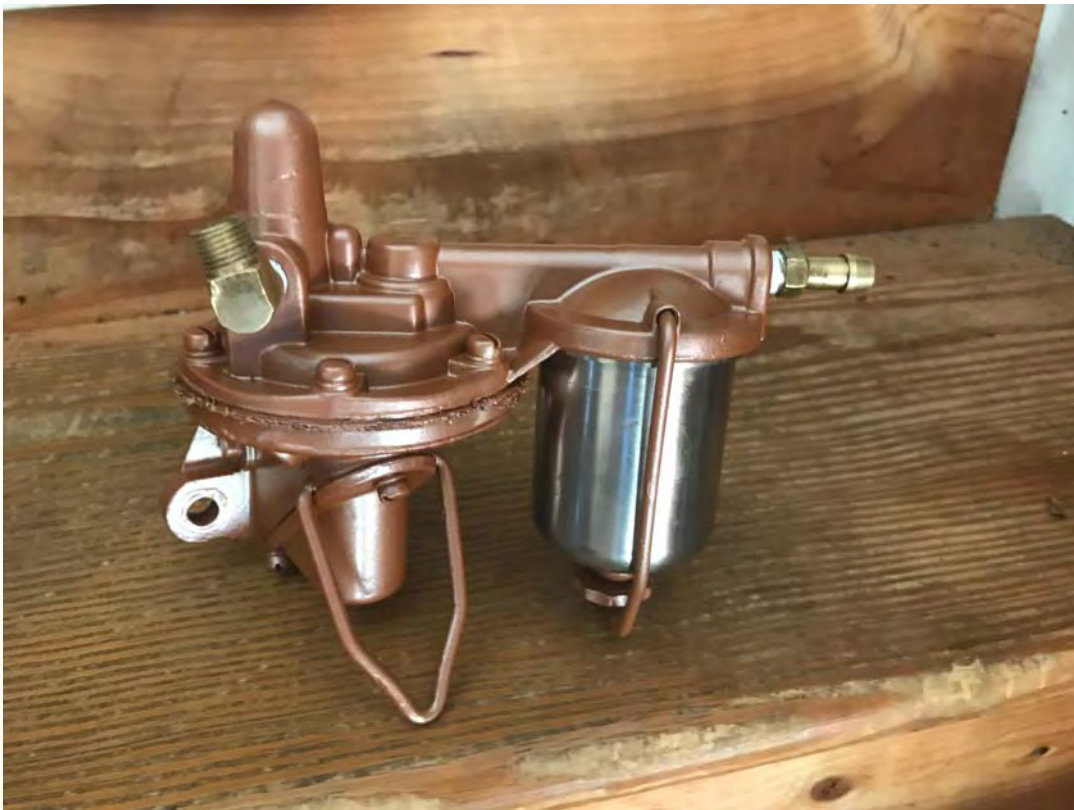
Finished Fuel Pump and Sediment Bowl

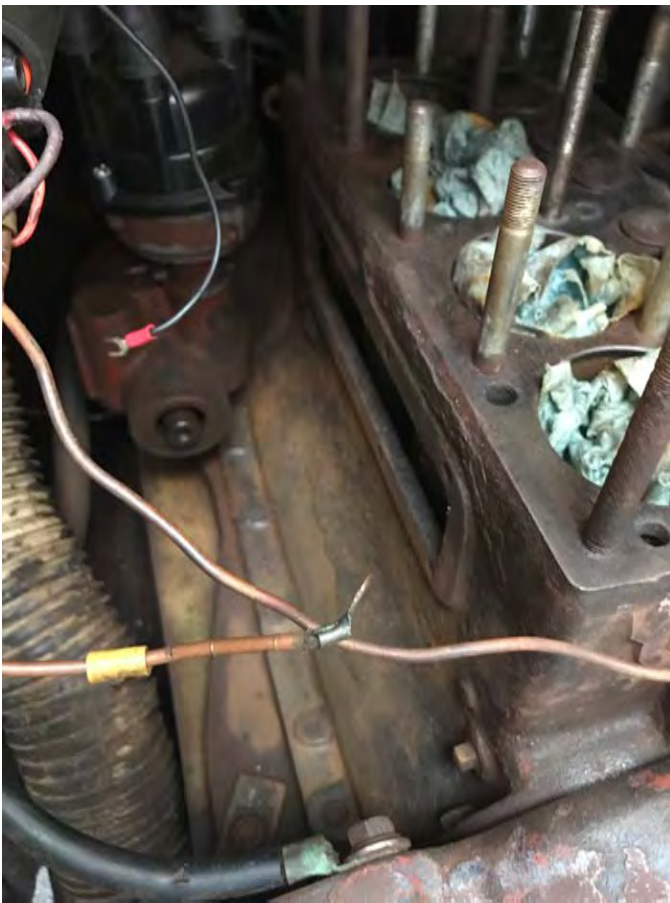
Final engine (starboard) descaling and cleaning

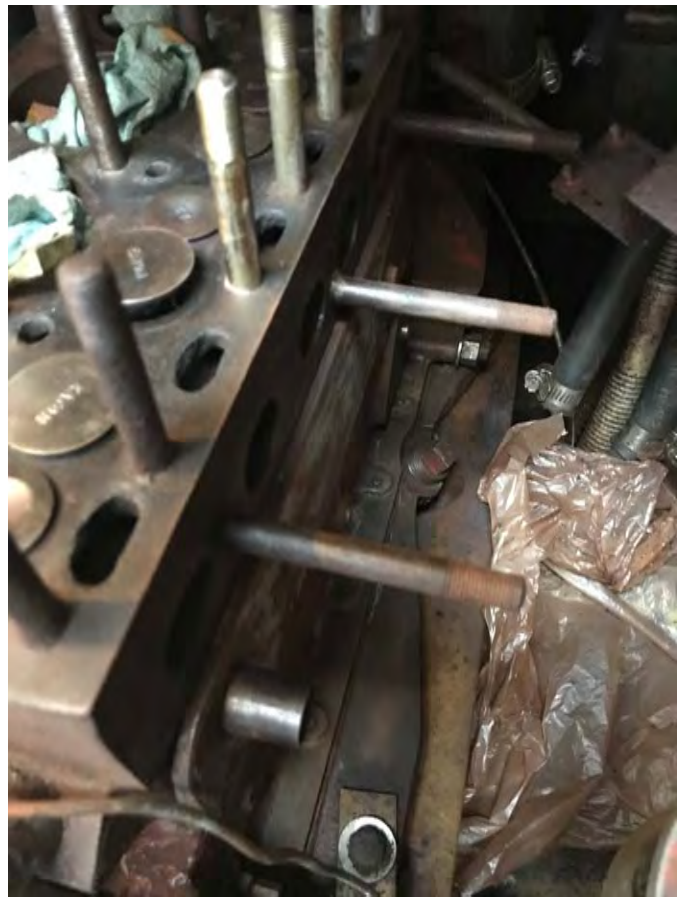
Final engine (port side) descaling and cleaning

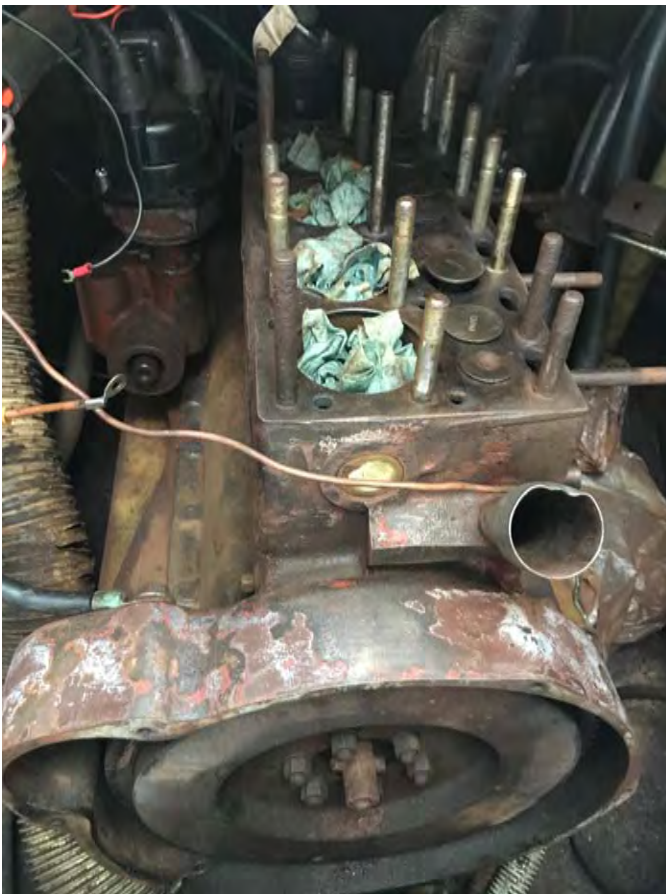
Final engine descaling and cleaning before self-etching primer coat

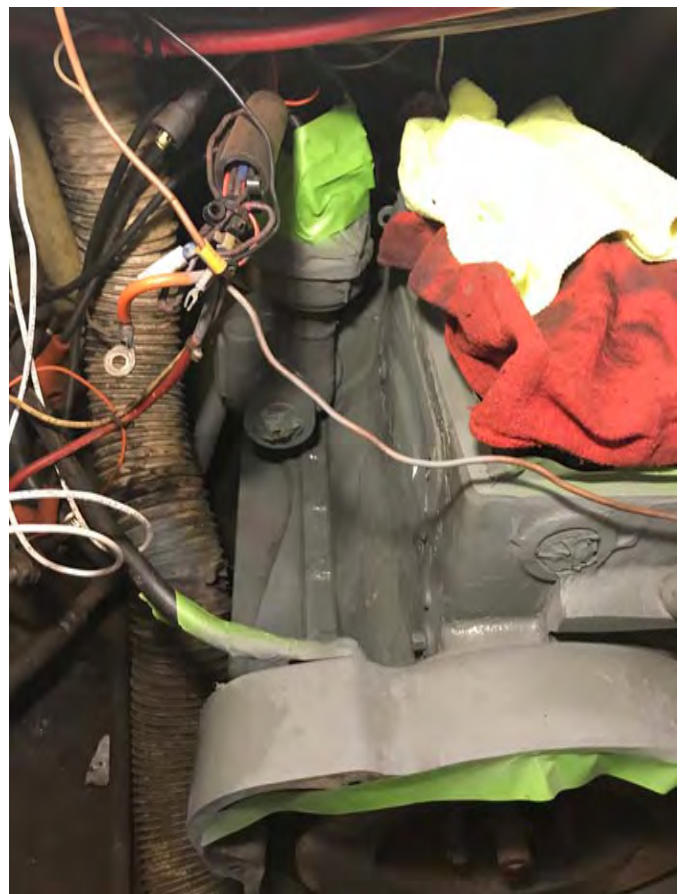
Primer Coat applied to engine (starboard side)

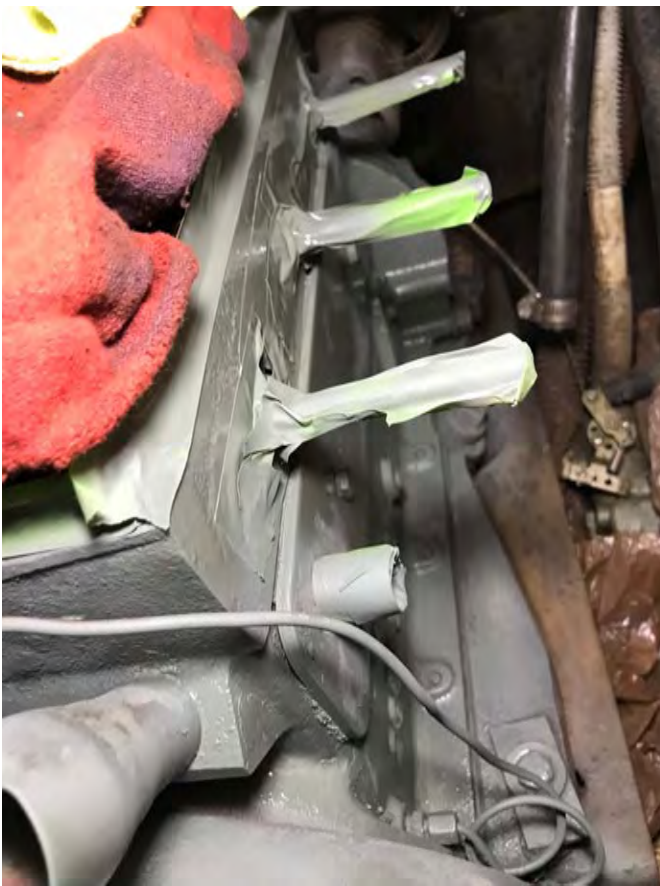
Primer coat applied to port side of engine

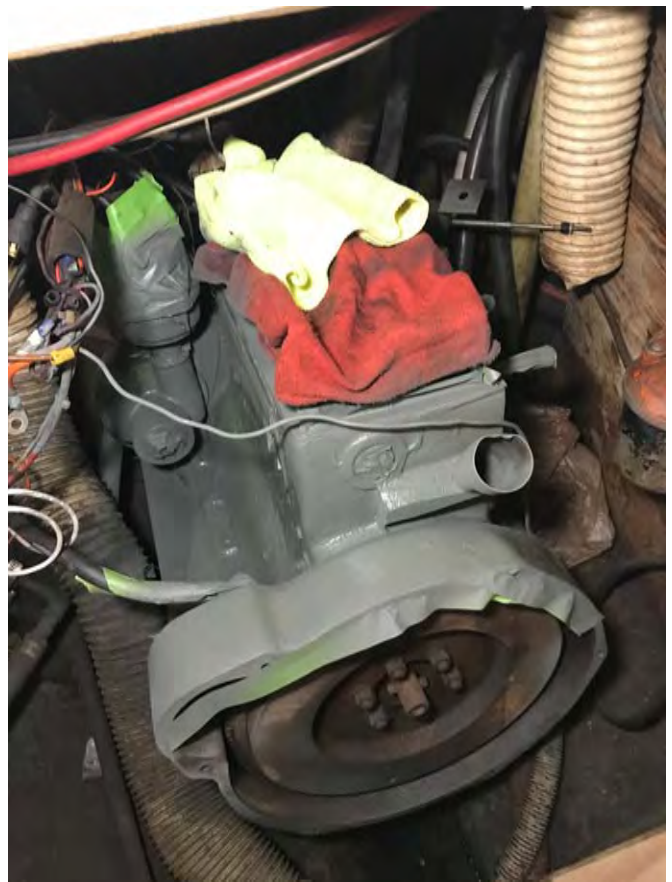
Final primer coat applied to engine

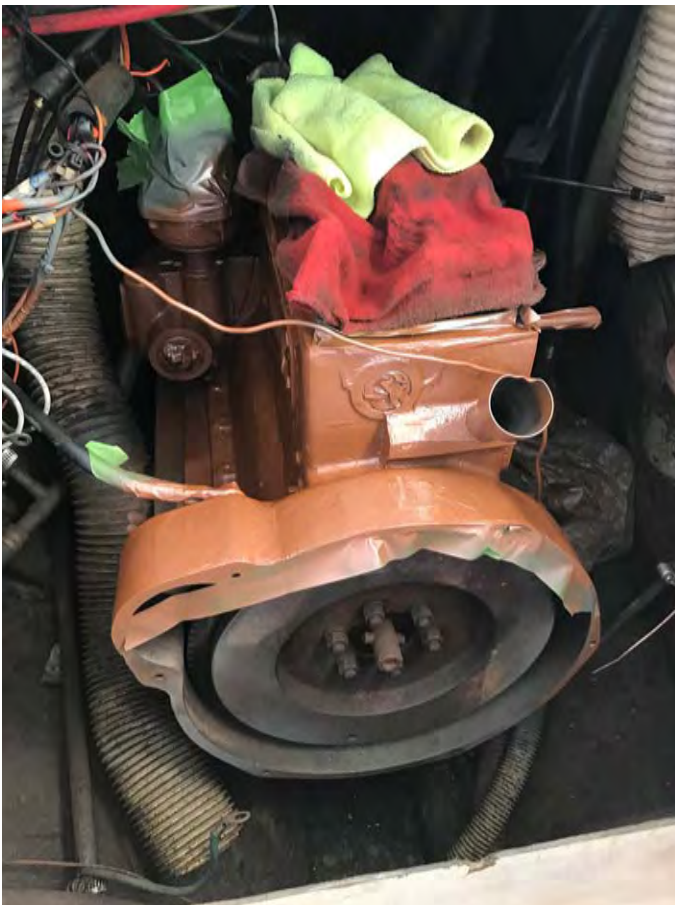
Applying "antique copper" high temperature spray paint to engine

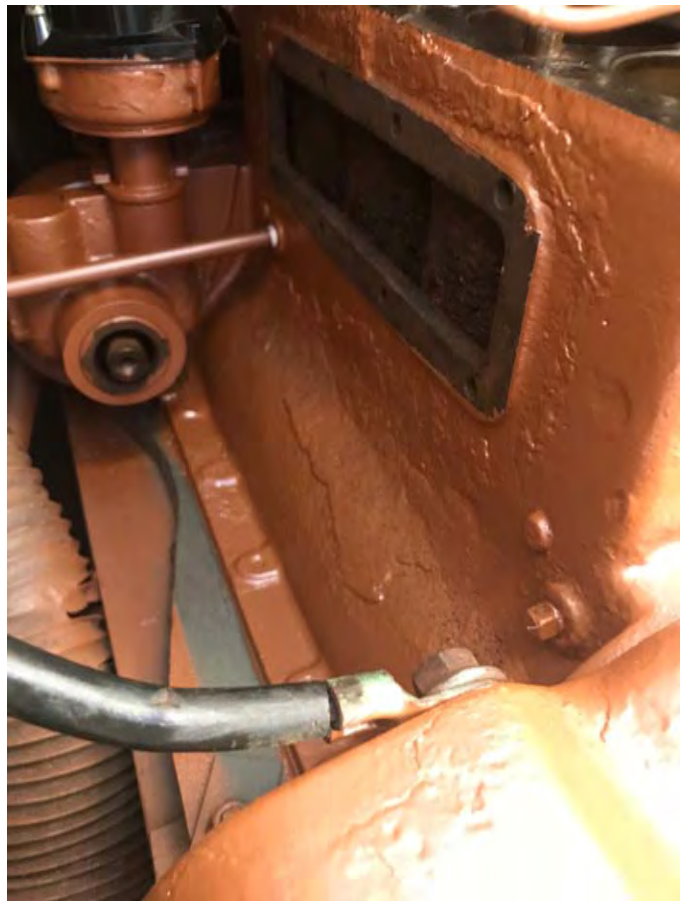
Finishing coat (starboard side)

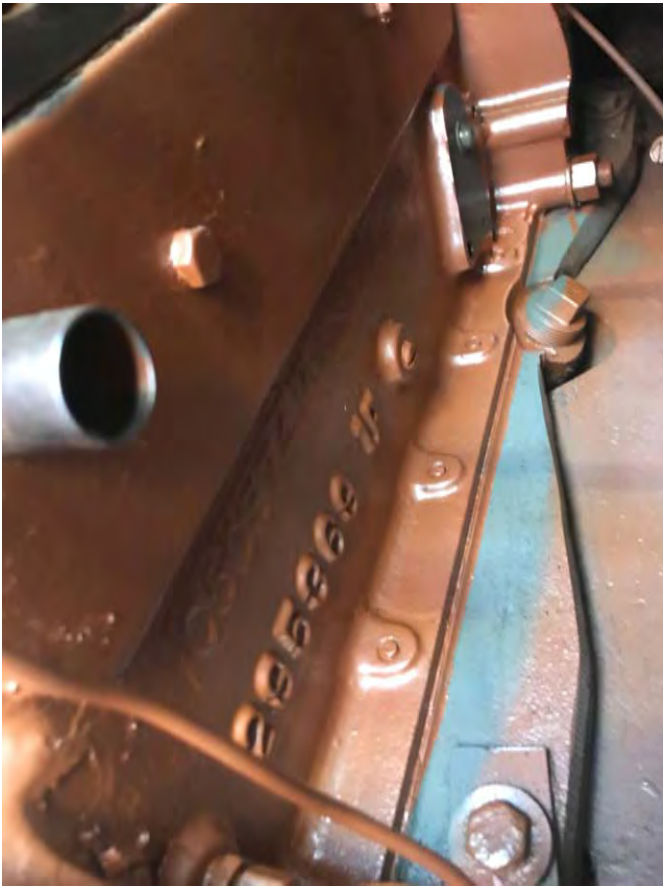
Finishing coat on port side of engine

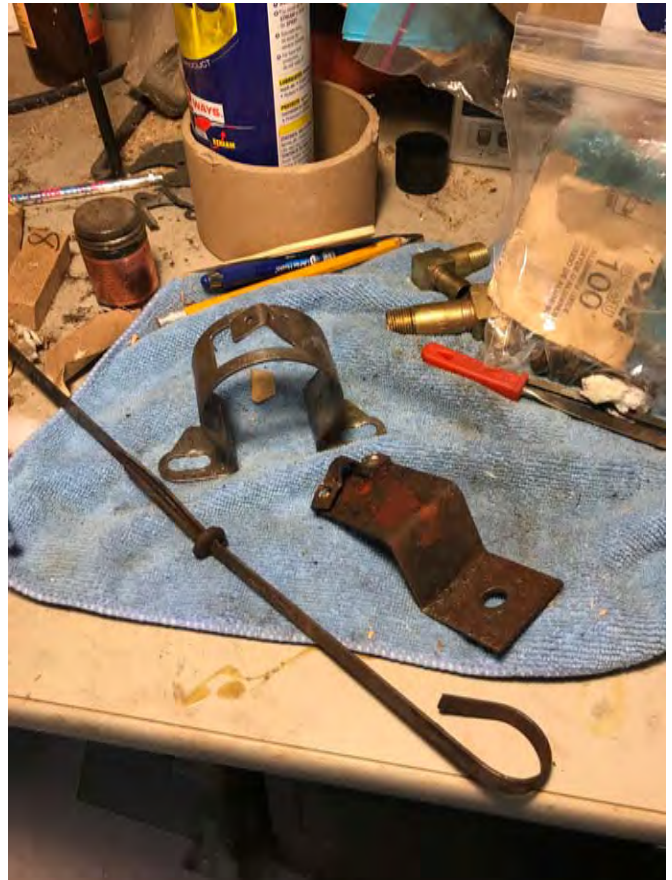
Ignition Coil Bracket, Dipstick,
and Throttle Bracket before cleaning

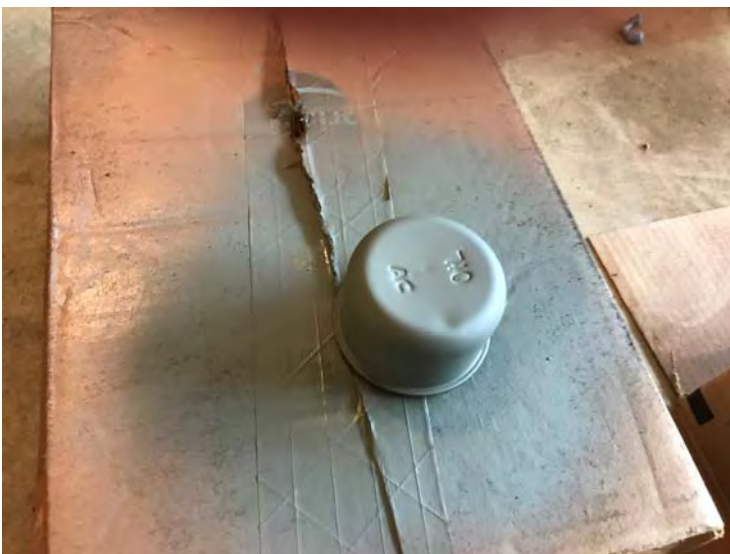
Oil Breather/Fill Cap with primer coat

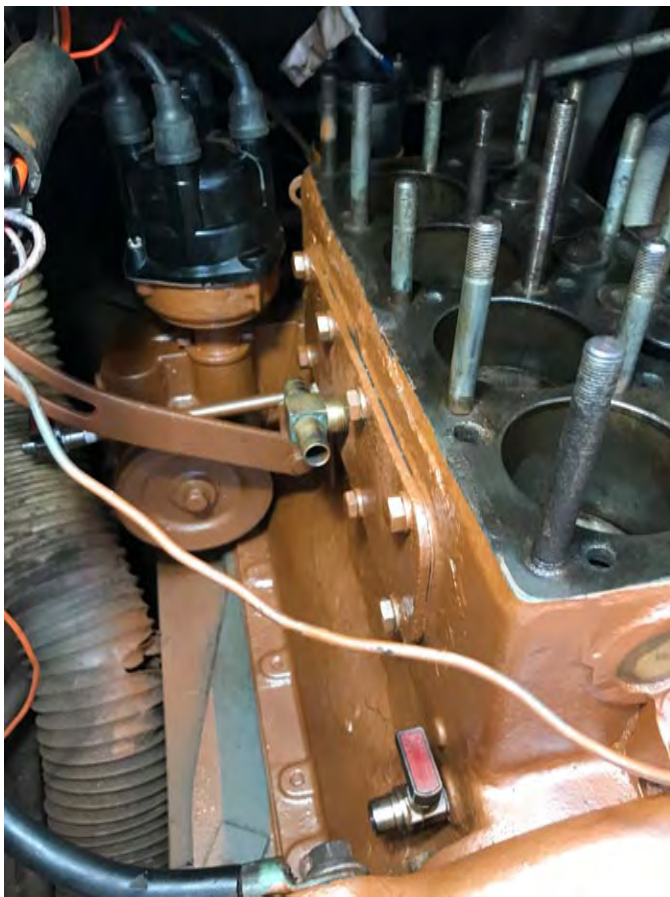
Engine (starboard side) painted and components reassembled

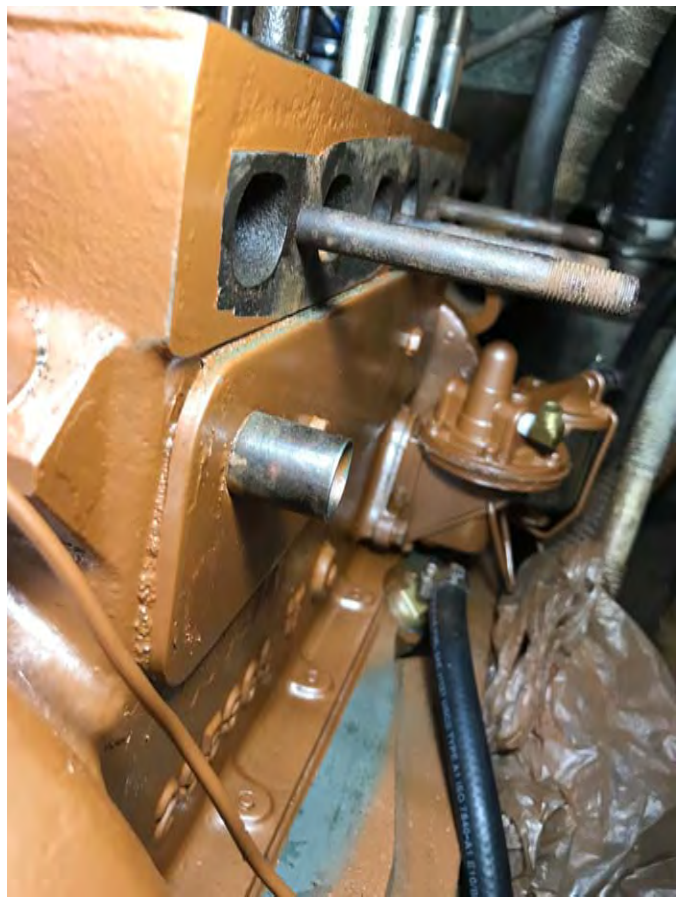
Engine (port side) painted and components reassembled

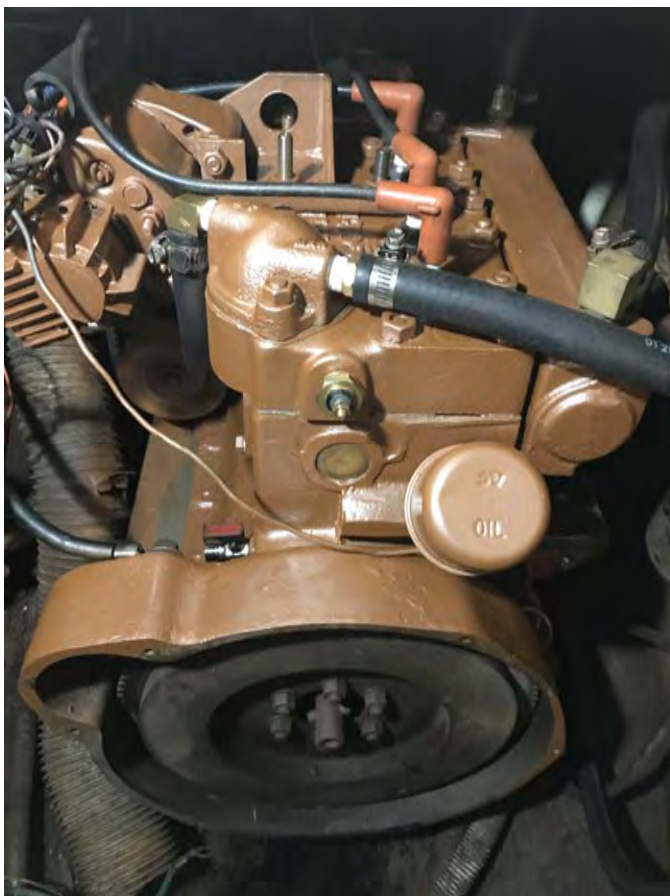
Engine reassembled without Flywheel Cover and Starter Motor

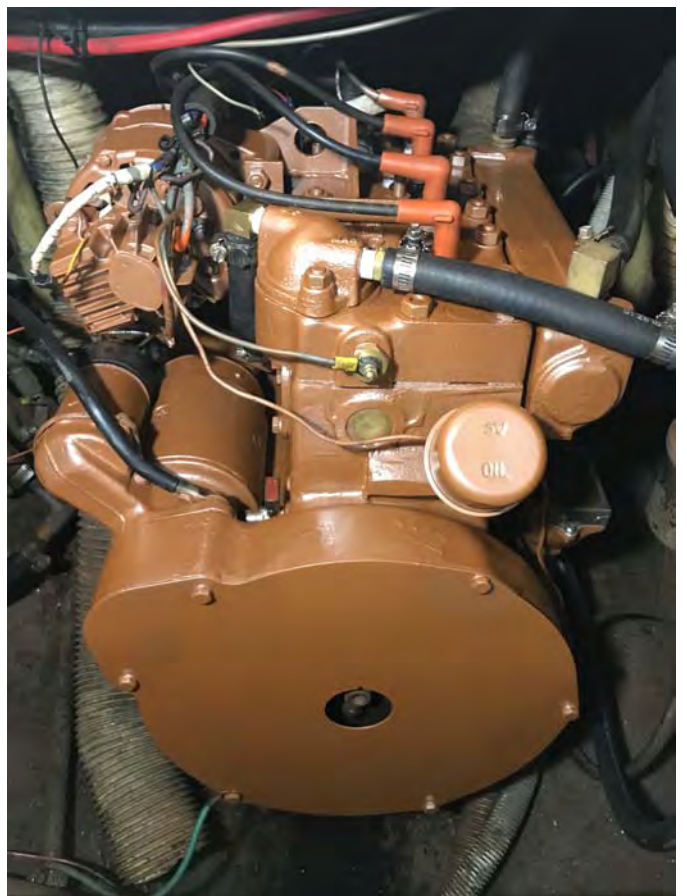
Engine with all painted comonents reassembled
