Major Maintenance and Repair Action

Hull 269 – Jade

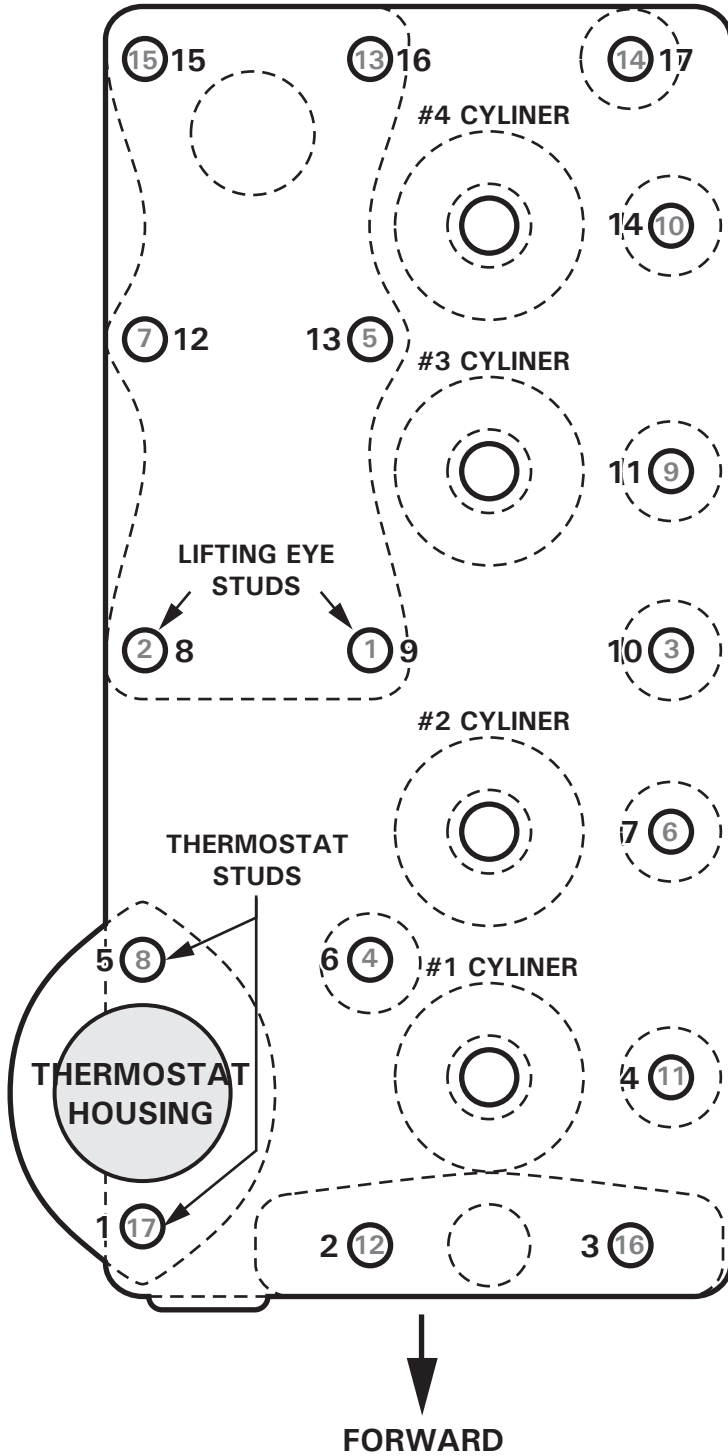
UNIVERSAL ATOMIC 4 CYLINDER HEAD DIAGRAM *(NOT TO SCALE)*

Numbers in Black: Stud Number from Front of Engine
Numbers in Gray: Cylinder Nut Torque Order
